By Eldon E. Mathauser, Bland A. Stein, and Donald R. Rummler

# TECHNICAL NOTE D-447

INVESTIGATION OF PROBLEMS ASSOCIATED WITH THE USE OF

ALLOYED MOLYBDENUM SHEET IN STRUCTURES

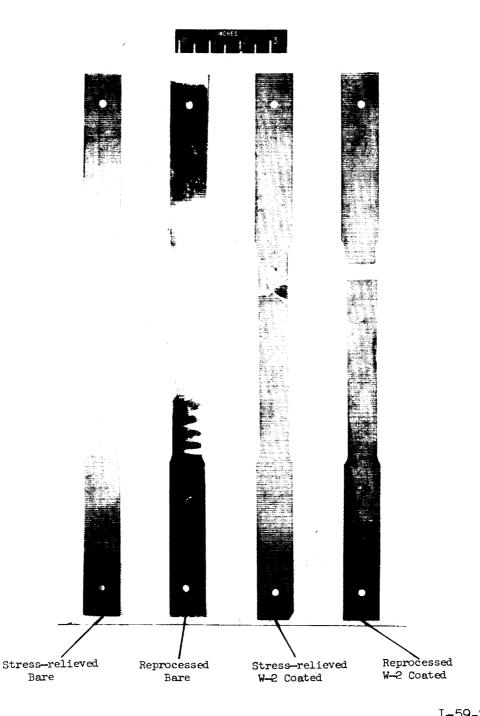
contrast, considerable difference exists between the elongation values. The elongation values of the bare and the coated reprocessed sheet were 1/3 and 1/2, respectively, of the elongation values of the bare and coated stress-relieved sheet. Examples of the room-temperature tensile stress-strain curves representative of the bare and coated sheet in the stress-relieved and in the reprocessed conditions are shown in figure 4. Figure 5 indicates the types of fractures that were obtained with the tensile specimens. Fractures characteristic of a brittle material were obtained in all specimens.

L-59-7933
Figure 5.- Examples of fractures obtained in room-temperature tensile stress-strain tests on bare and coated Mo-0.5Ti sheet. Thickness of stress-relieved sheet, 0.013 inch; thickness of reprocessed sheet, 0.010 inch.

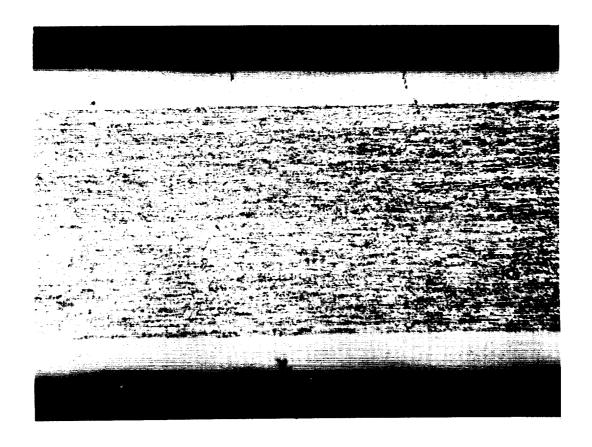
Cross-sectional views of the coated Mo-0.5Ti sheet in the reprocessed condition are given in figures 14 to 16. In figure 14 a nominal 0.001-inch-thick coating on the 0.010-inch-thick reprocessed sheet is indicated. This thickness of coating produces a 4-percent weight increase in the molybdenum sheet. This coating is representative of that applied on both the tensile specimens and the corrugated-core sandwiches. In figure 15 is shown the W-2 coating with a nominal coating thickness of 0.002 inch. This coating thickness produced a 7-percent weight increase in the bare sheet. This view was obtained from one of the oxidation specimens that were coated by the modified coating method previously outlined.

L-60-2455
Figure 14.- The W-2 coated Mo-0.5Ti sheet in reprocessed condition.
Sheet thickness, 0.010 inch; coating thickness, 0.001 inch (this is representative of the coating used on tensile stress-strain specimens and corrugated-core sandwiches); x250.

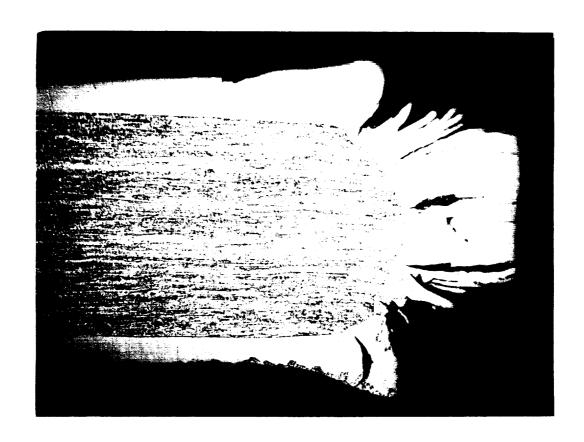
L-60-2456
Figure 15.- The W-2 coated Mo-0.5Ti sheet in reprocessed condition.
Sheet thickness, 0.010 inch; coating thickness, 0.002 inch (this is representative of the coating used on oxidation specimens and was applied by modified coating process); x250.

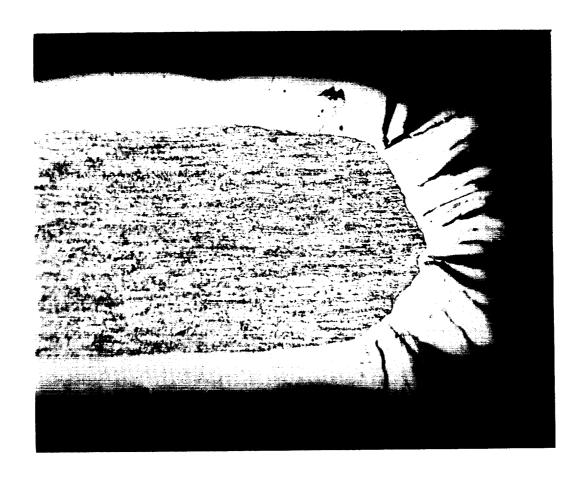
(a) Coating thickness, 0.001 inch; x250.

Views of the edges of the W-2 coated sheet are given in figure 16. Figure 16(a) indicates the edge of a sheet with a nominal 0.001-inch W-2 coating. Note that an irregular buildup of the coating occurred at the edge that would be prone to fracture. A view of an edge of a sheet that was coated to a nominal thickness of 0.002 inch by the modified coating method is shown in figure 16(b). Some improvement in the uniformity of

Figure 16.- Edge view of W-2 coated oxidation specimen. Mo-0.5Ti sheet in reprocessed condition. Sheet thickness, 0.010 inch.

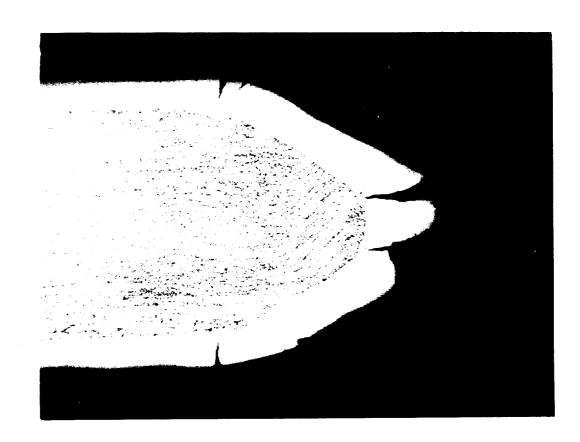
the coating on the edge of the sheet was obtained with this modified coating method. Further improvement in the uniformity of the coating on the edge was obtained by rounding and beveling the edge of the sheet as indicated in figure 16(c). It appears that the coating shown in figure 16(c) would be least prone to fracture and that the coating shown in figure 16(a) would be damaged most easily. The edges of the oxidation specimens for which results are given in figure 13 generally resembled the edge view shown in figure 16(b).

L-60-2458 (b) Coating thickness, 0.002 inch applied by modified coating process;  $\times 250\,.$

L-60-2459 (c) Coating thickness, 0.002 inch applied by modified coating process; edge of sheet beveled to improve uniformity of coating; x250.

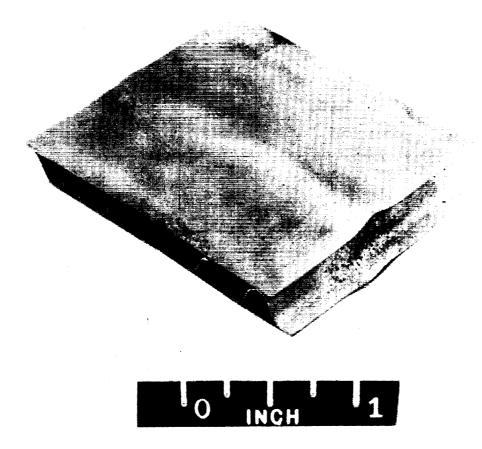
would occur in the inelastic or plastic stress range of the Mo-0.5Ti sheet. In the axial compressive strength tests on the sandwiches, wrinkles rather than local buckles were obtained. The wrinkles extended across the face sheets at right angles to the direction of loading shown in the view of the tested specimen in figure 19. The formation of the wrinkles probably occurred because of large spot-weld spacing. The nominal spacing for the spot welds was 1/3 inch. The maximum strength of the sandwiches was probably affected by the formation of these wrinkles; however, an accurate estimate of the magnitude by which the maximum load was reduced cannot be made without compression stressstrain data which were not obtained in this study. The distance between welds was dictated by practical considerations associated with the resistance welding of thin molybdenum sheet. Attempts to produce resistance welds that were spaced more closely resulted in shunting of the electrical power through the adjacent weld. Further efforts will be required to develop resistance welding techniques that will permit close spacing of the spot welds. On the basis of the strength test results the performance of the resistance welds was judged to be satisfactory at all temperatures. It is recognized that axial loading tests may not provide a critical test for the quality of the welds. Various additional tests would be required to establish the performance and limitations of the resistance welds.

Figure 19.- Molybdenum sandwich after axial compressive strength test. Test temperature, 2,400°F; compressive load was applied in the direction of the corrugations.

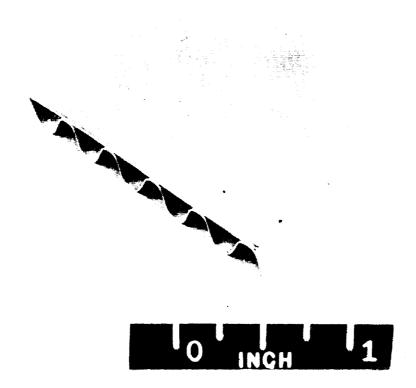
sandwich specimen was exposed at 2,700° F for 3.2 hours. In this test molybdenum trioxide was noted after approximately 2 hours of exposure. An example of the type of failure that occurred in the oxidation test is shown in figure 21.

The coated sandwich specimen prior to testing is shown in figure 21(a), and the specimen after exposure at 2,700° F for 3.2 hours is shown in figure 21(b). Oxidation damage is visible; however, the full extent of this damage is not evident because the coating covers some of the oxidized areas. The full extent of the oxidation damage is indicated in part (c) of figure 21 which shows the same specimen viewed from approximately the same direction. A probe was used to remove the coating to reveal the holes that had been oxidized in the molybdenum sheet. Examination of the oxidized specimen indicates that most of the oxidation damage occurred at the spot welds. It appears that the welds were not coated adequately although the areas along the weld lines between the welds were protected satisfactorily by the coating. result suggests that the welds were not cleaned sufficiently prior to application of the coating. It is believed that the surface cleanliness in the weld area rather than difficulty of access for the coating is primarily responsible for the type of oxidation failure that was obtained.

Figure 21.- Example of W-2 coated Mo-0.5Ti sandwich before and after oxidation test in furnace at 2,700° F. Time at test temperature, 3.2 hours.

(b) Appearance of sandwich specimen after removal from furnace at  $2,700^{\circ}$  F.

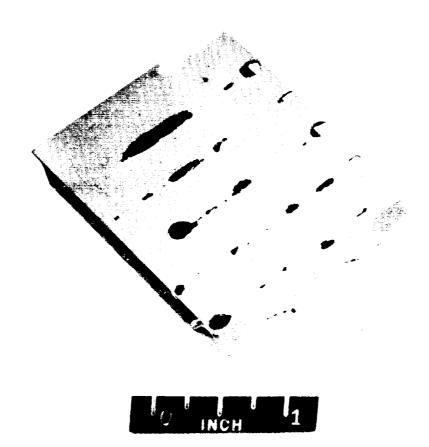
(c) Appearance of specimen after coating has been removed to expose oxidized areas in face sheet and core. The oxidized areas are located at the spot welds.

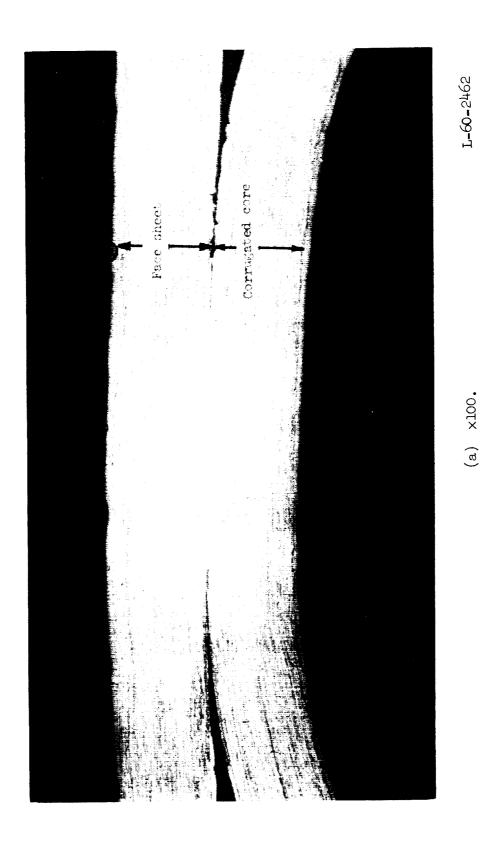
A cross-sectional view of the weld area in the coated sandwich is shown in figure 22. This specimen was obtained from a coated sandwich that had been subjected to axial compressive loading at room temperature to determine maximum strength. The upper sheet shown in the figure indicates the 0.010-inch-thick face sheet and the lower curved sheet indicates the corrugation. Note that a relatively uniform layer of W-2 coating is visible on the upper surface of the face sheet and on the lower surface of the corrugation. By comparison, relatively little coating is visible on the lower surface of the face sheet or on the upper surface of the corrugation particularly in the area adjacent to the weld. An enlarged view of a portion of this weld area is shown in part (b) of figure 22. This enlarged view shows the right-half portion of part (a) of figure 22 and is included to illustrate more clearly the lack of coating on the inner surfaces adjacent to the weld area. Practically no evidence of the coating can be seen on the surfaces at the junction between the face sheet and the corrugation.

Figure 22.- Example of resistance weld and coating in W-2 coated Mo-O.5Ti sandwich specimen.
